# **Stony Run Streambank Restoration**

## **East Cocalico Township**

### **Community Conservation Grant - Clean Water Fund**

#### **Project Details**

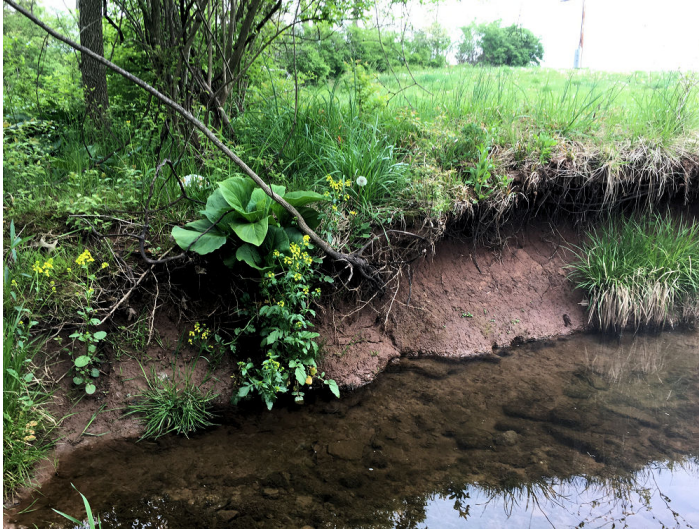
1-Streambank before restoration

The area of Stony Run selected for this project flows through a mowed area between Hill Road and a wooded portion of the site. The land is owned by the Township. The area within the woods included wetlands, therefore that area was not part of the project to avoid the permitting issues related to the wetlands. The total length of the stream selected for this project was 265 feet. At each location there was significant erosion on only one side of the stream – on the outside of the meanders. In all cases the opposite side of the streambank was fully vegetated and without steep slopes. On the eroding sides of the stream the vertical bank height ranged from 3.0 to 4.0 feet.

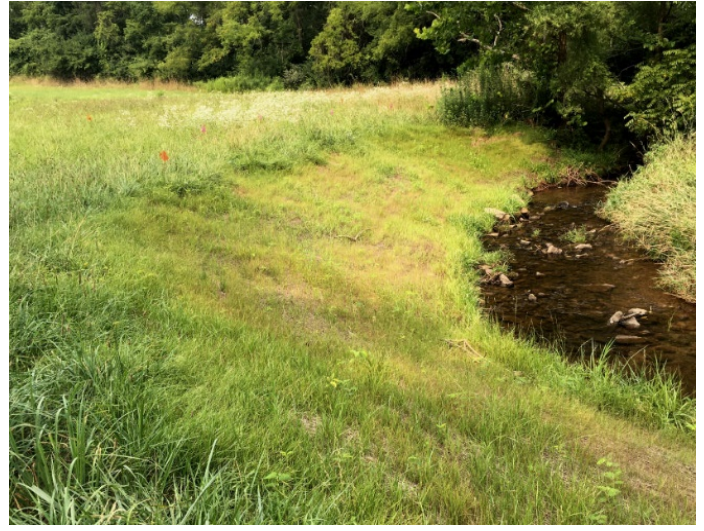
2-Streambank after restoration

The earth moving for the project was delayed until the weather would allow for the disturbed areas to revegetate rapidly. The actual work was done in May 2021. The eroding streambanks were modified to a 1V:2H slope to reduce the erosive force of the water, especially during storm events. After the slopes were reduced, they were seeded with a native plant mix from Ernst Seeds, (ERNMX-263, “Piedmont Province Riparian Mix”). After seeding, the exposed soils were covered with matting (Rollmax BioNet S-150BN Erosion Control Blanket).

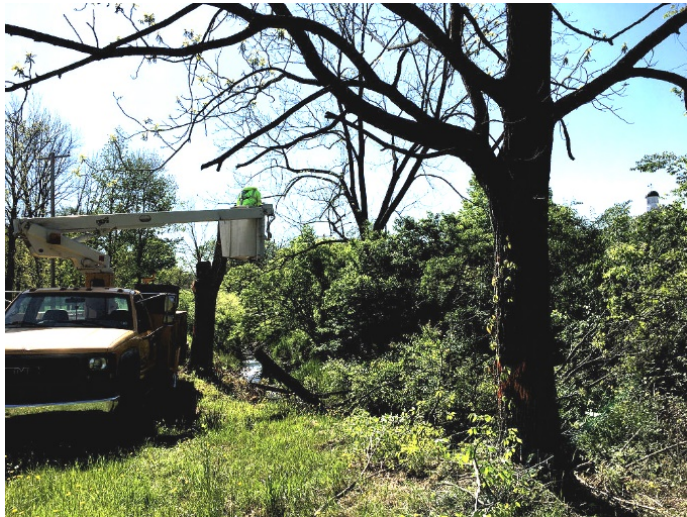
3-Removing walnut trees at top of bank

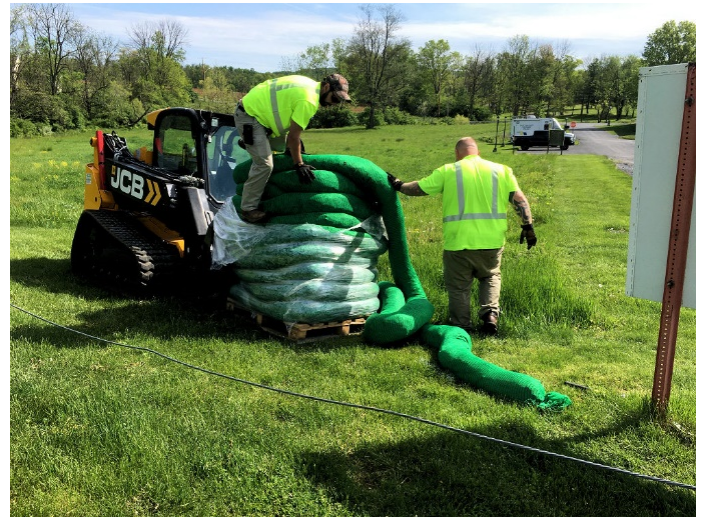
4-Installing silt-sock at soil disposal area

The earthmoving to reduce the slopes of the eroding banks produced an estimated volume of soil of 107 cubic yards. As the soil was excavated it was placed directly into a dump truck and moved to the “soil disposal area” a few hundred feet from the stream (protected by a “silt sock”), and out of the flood plain. After all of the soil had been relocated, the area was also reseeded.

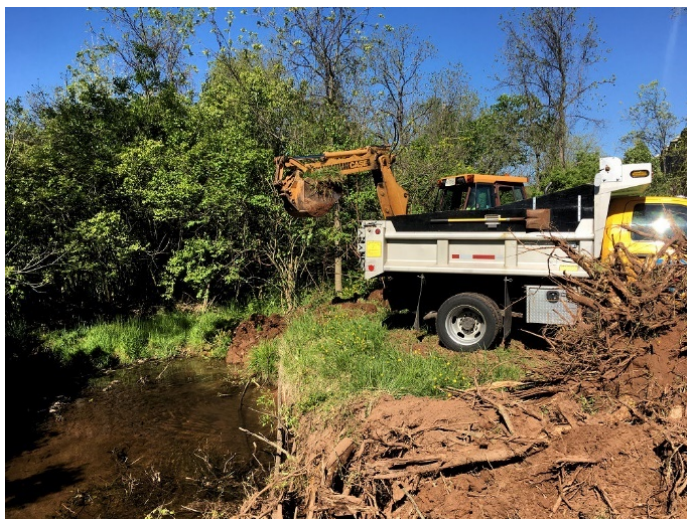
5-Excavation of soil from banks

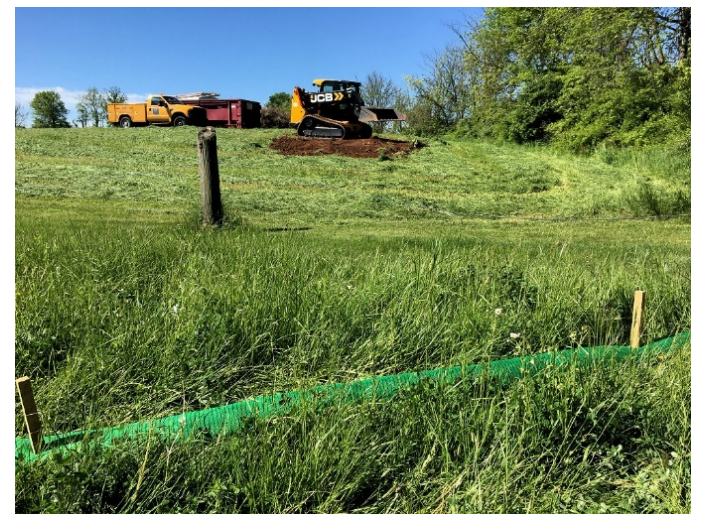
6-Spreading soil in disposal area

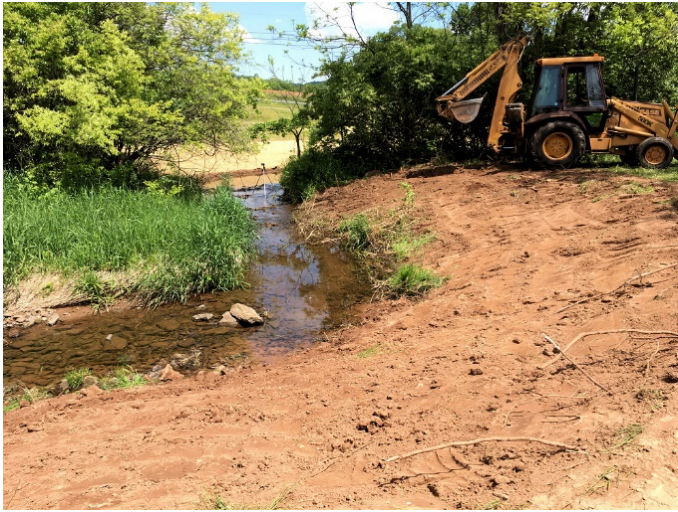
7- Excavation completed

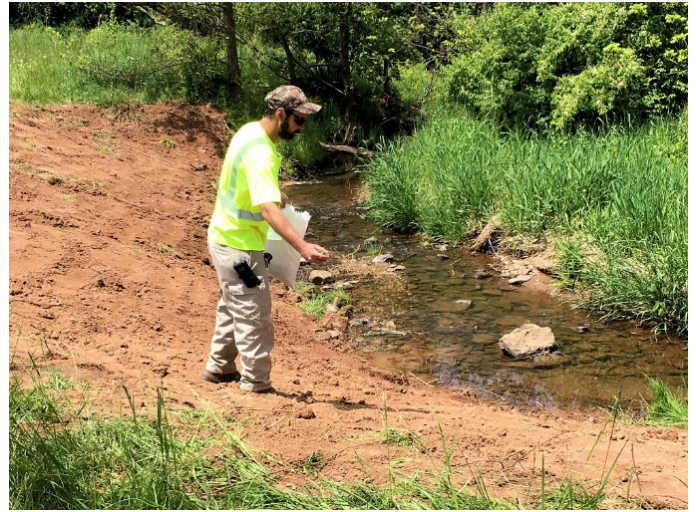
8- Seeding banks

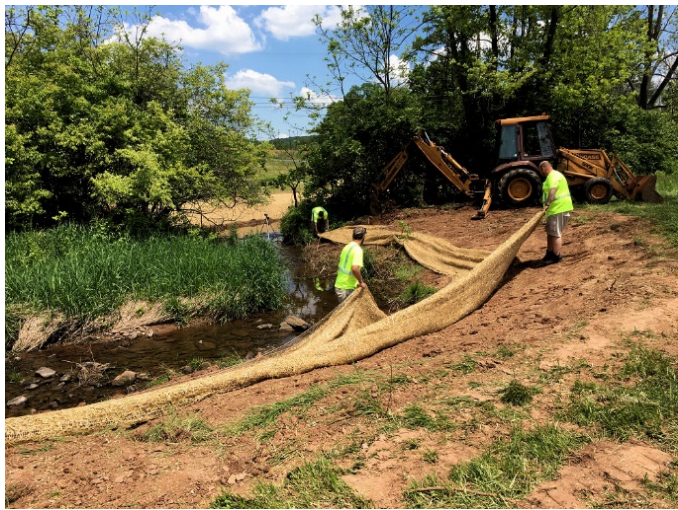
9- Installing protective matting

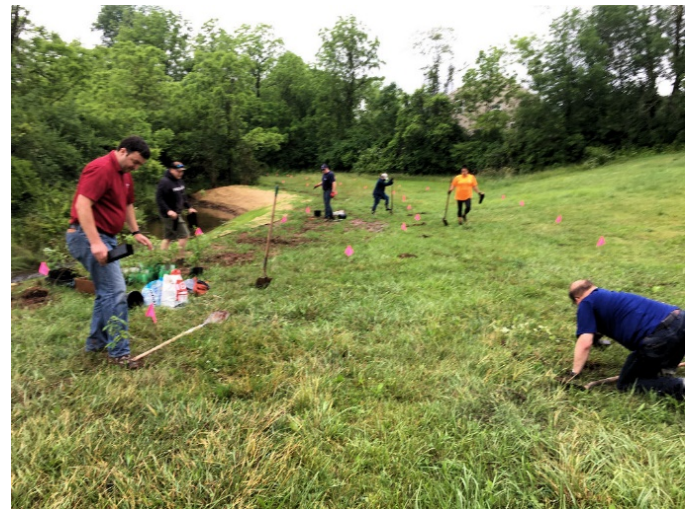
10- UGI volunteers planting trees and shrubs

With the help of volunteer UGI employees, we planted 139 trees and shrubs adjacent to the reach of the stream where the project was done. We have ordered additional plants for fall delivery that will be added to the buffer zone/live-stake nursery.

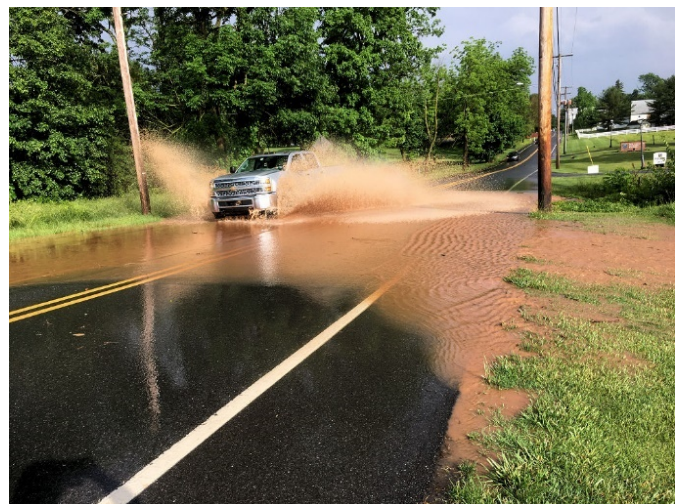
11-Hill Road flooding on June 8, 2021

Since the project was completed, we have had several substantial storms. On June 8, 2021 in response to a severe thunderstorm, the stream rose to near bankfull without any apparent damage to the matting or the slopes. With a fairly dry summer, the seed mix has been slow to become established. However, it should fill in more fully when we get additional rainfall.

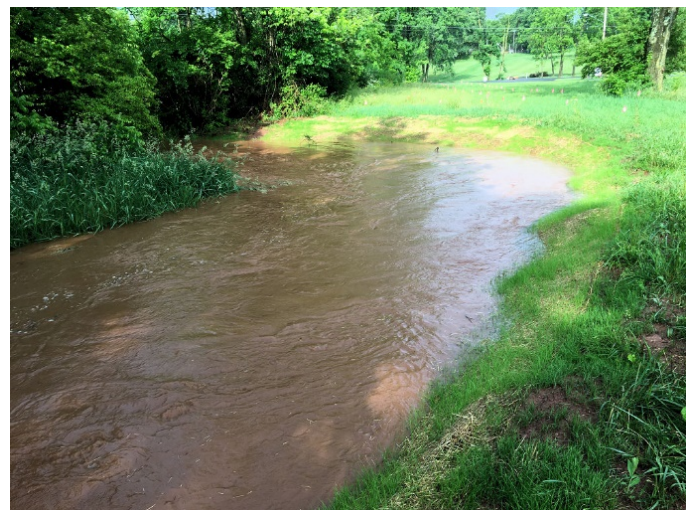
12- Flooding on June 8, 2021

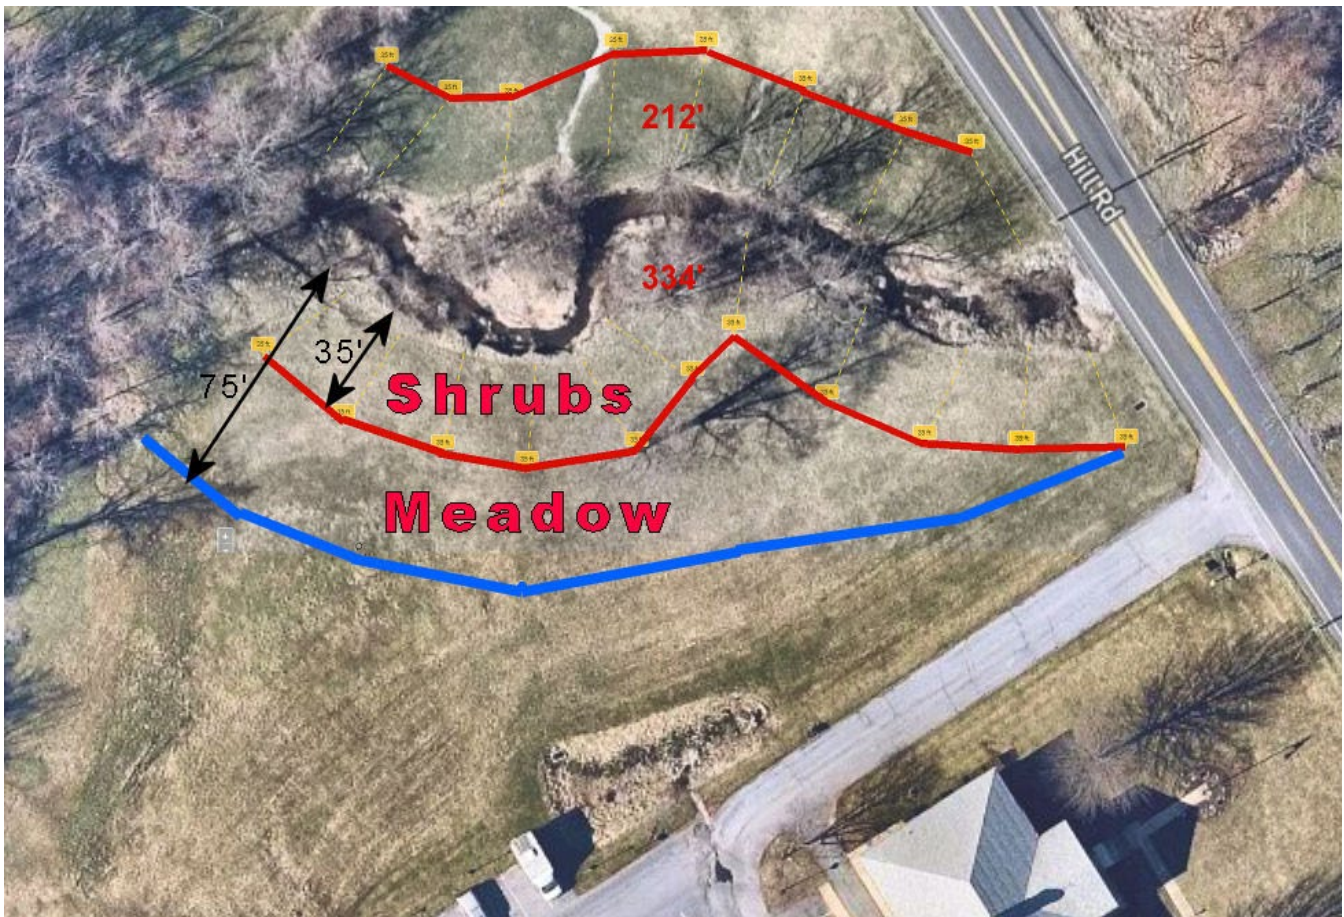
15-Riparian buffer around project

Using trees and shrubs provided through the Ten Million Trees project, we obtained a variety of species that were planted into the riparian buffer around the project. The total buffer width is 75 feet. Around half of that distance will be wildflower meadow, and the remainder will be planted with trees and shrubs. The side of the project facing the Township building is limited to shrubs which will be kept to a height limit of four feet because of safety concerns related to the Police Station located in the Township building. The concern is to not create locations where people could potentially hide and ambush officers. Other trees near the Police Station were removed several years ago for the same reason, and the corn grown in the leased farm field around the Township Building has been replaced with a forage crop.
