What to Look for When Inspecting a Stormwater Basin

What is a stormwater basin and how do they work?

Problems in basins

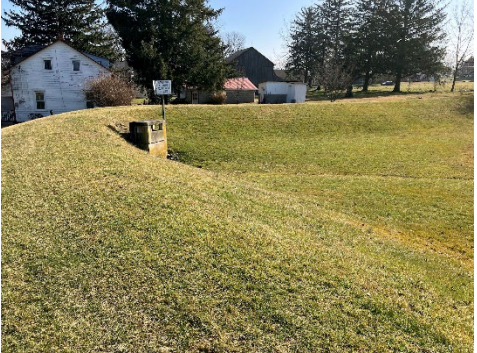
<p>Berm – the earthen structure that holds water in the basin.</p>

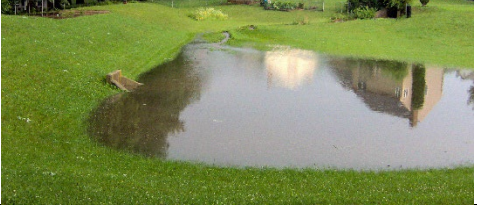
<p>Storage volume – where the basin holds the water.</p>

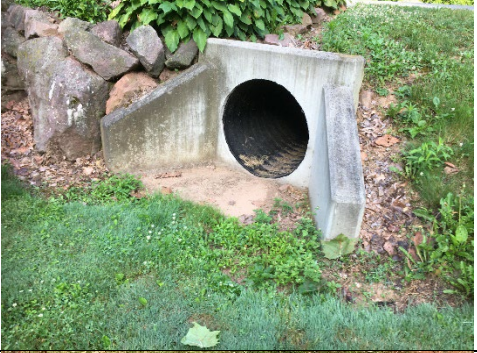
<p>Inlet/Endwall – the way water gets into the basin, such as from a pipe or swale. An endwall is a structure located at the downstream end of a pipe.</p>

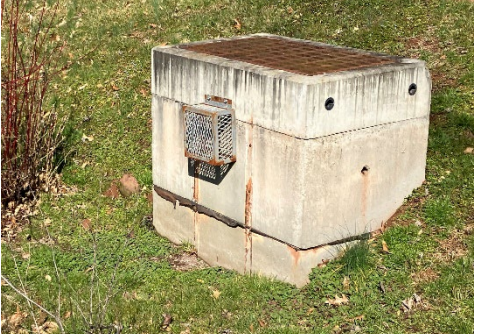
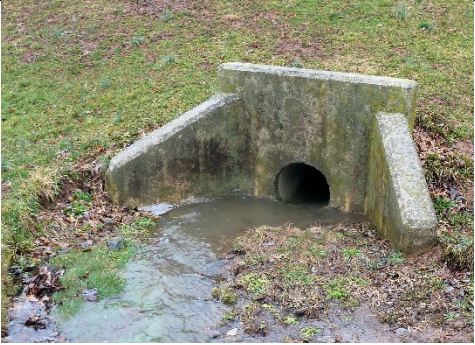
<p>Outlet – the structure that controls how fast the water leaves the basin.</p>

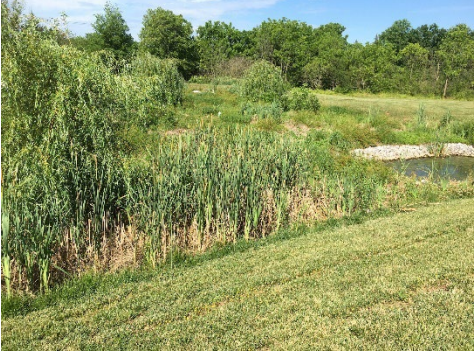
<p data-bbox="803 451 1274 535">Early outlet structure (flood control only).</p>
<p data-bbox="300 567 771 861">Vegetation – plants such as grass or wetland species that protect the soil or medium from being washed away (eroded). They can also improve water quality by removing nutrients.</p>

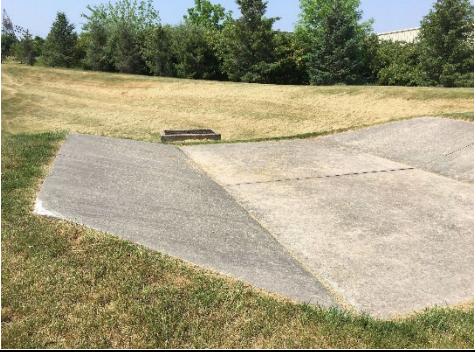
<p data-bbox="300 924 771 1218">Emergency spillway – a low point in the berm that allows water to overflow in a controlled manner if it gets too deep. Some are grass and some are concrete lined as in this example.</p>

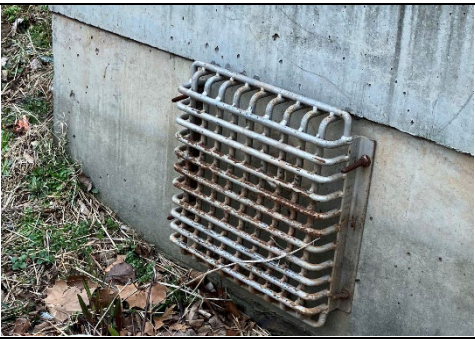
<p data-bbox="300 1480 771 1606">Trash Rack – metal grid used to keep trash and larger debris from clogging the outlet</p>

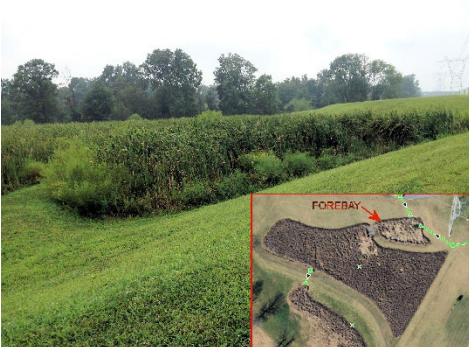
<p>Forebay – separate area at the inlet used to trap debris and sediment and keep it out of the main part of the basin.</p>

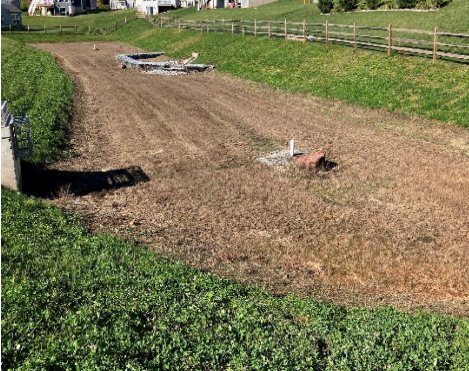
<p>Infiltration medium – modified soil that allows water to soak into the ground. This one is still being established, so it is not covered with vegetation yet. Note forebay near far end. For inspection of an infiltration basin, see: Infiltration</p>

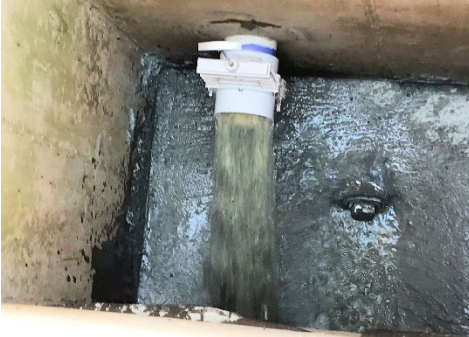
<p>Underdrain – perforated pipe under the infiltration medium that allows the basin to be drained. Under the ground in the basin, it is visible in the outlet structure (shown opened).</p>

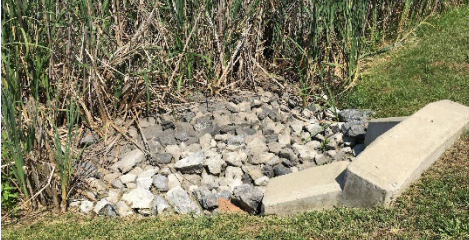
<p>Rock Apron – area of large stones (rip-rap) used to slow the flow of water at the inlet and/or outfall to reduce erosion.</p>

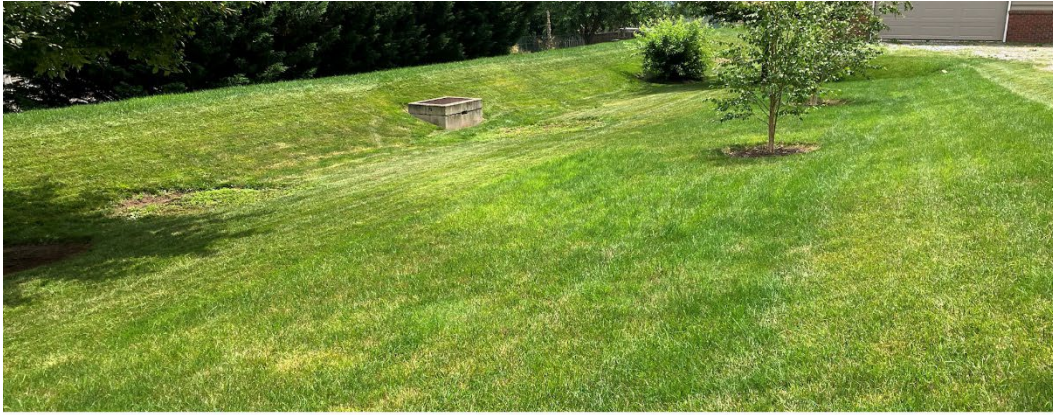
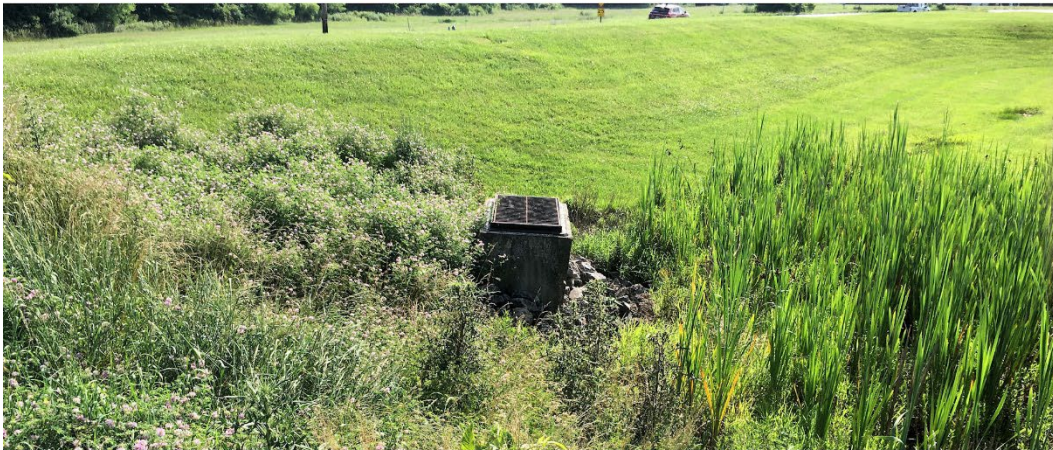
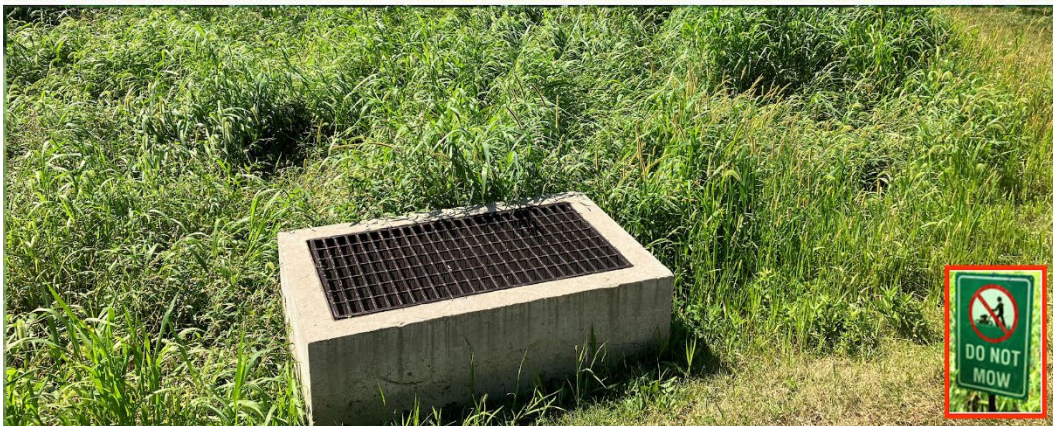
Unless the mowing frequency is defined in the maintenance instructions for your basin, there are options for how often to mow in the basin. In situations like the top example it may be desirable to keep the basin mowed in the same way as the rest of the lawn. If part of the basin remains wet, as in the middle example, mowing only the dry areas may make sense. It will not hurt the function of the basin to only mow it once or twice a year, as in the basin on the bottom. More vegetation means larger root systems, better erosion prevention and greater water uptake and transpiration. The vegetation also helps with filtration and sediment trapping. Unless the basin is too wet to mow, it should be mowed at least once per year to prevent the growth of trees and shrubs which could damage the basin. If you are not mowing the basin, be sure to keep the inlets and outlets clear, trash racks clean, and to keep woody plant species under control.

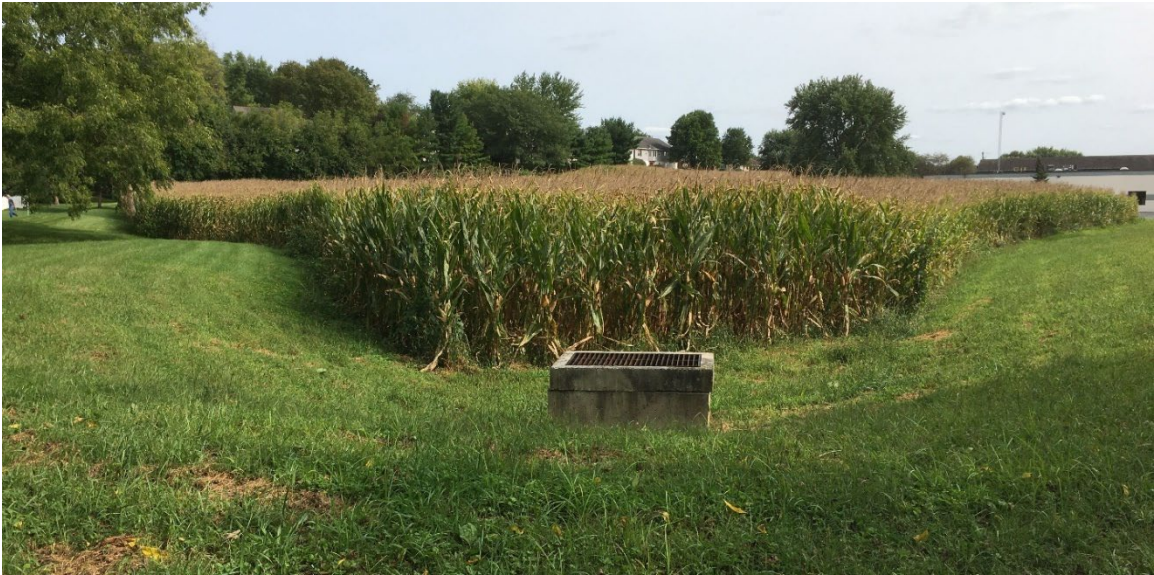
Basins should remain free from obstructions. In this case, because it was shallow, the farmer who was leasing the land didn't realize that he had planted corn in a stormwater basin.

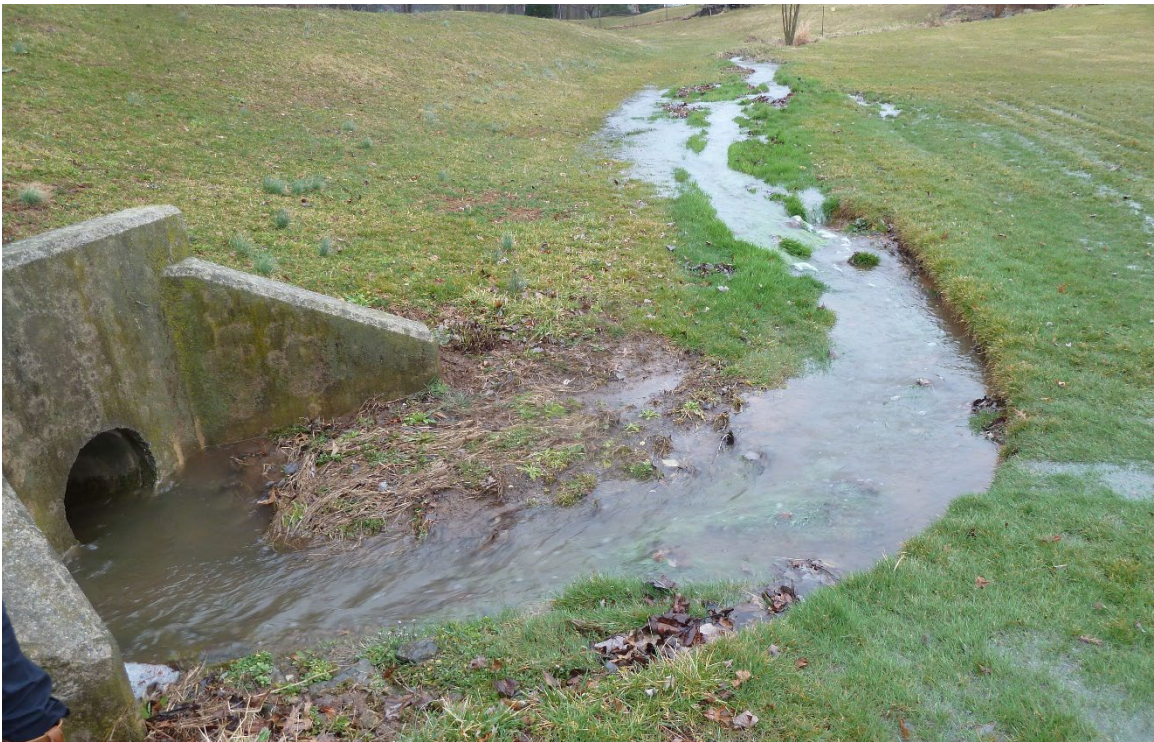
If there is a spring or other source of frequent flow in a basin it can erode a channel from the inlet to the outlet. This can happen without frequent flow. In basins where the problem is recognized in the design stage, a small concrete lined swale (called a low-flow channel) can prevent erosion. If that is not the case, then steps need to be taken to prevent the erosion.

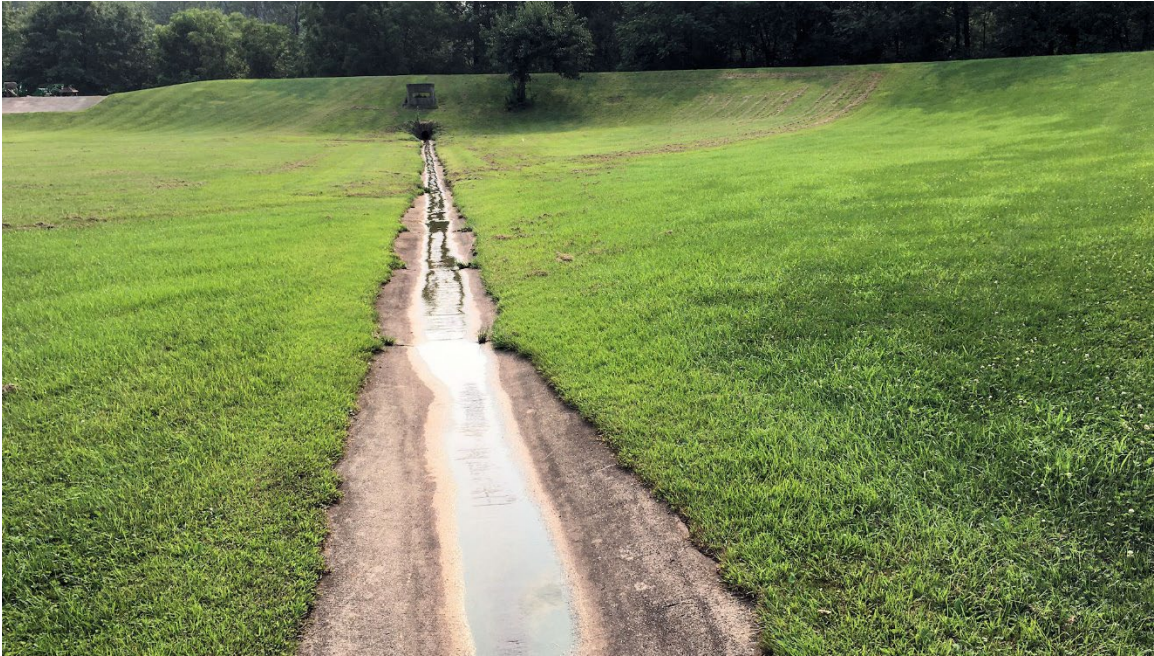
A concrete lined low-flow channel can prevent erosion.

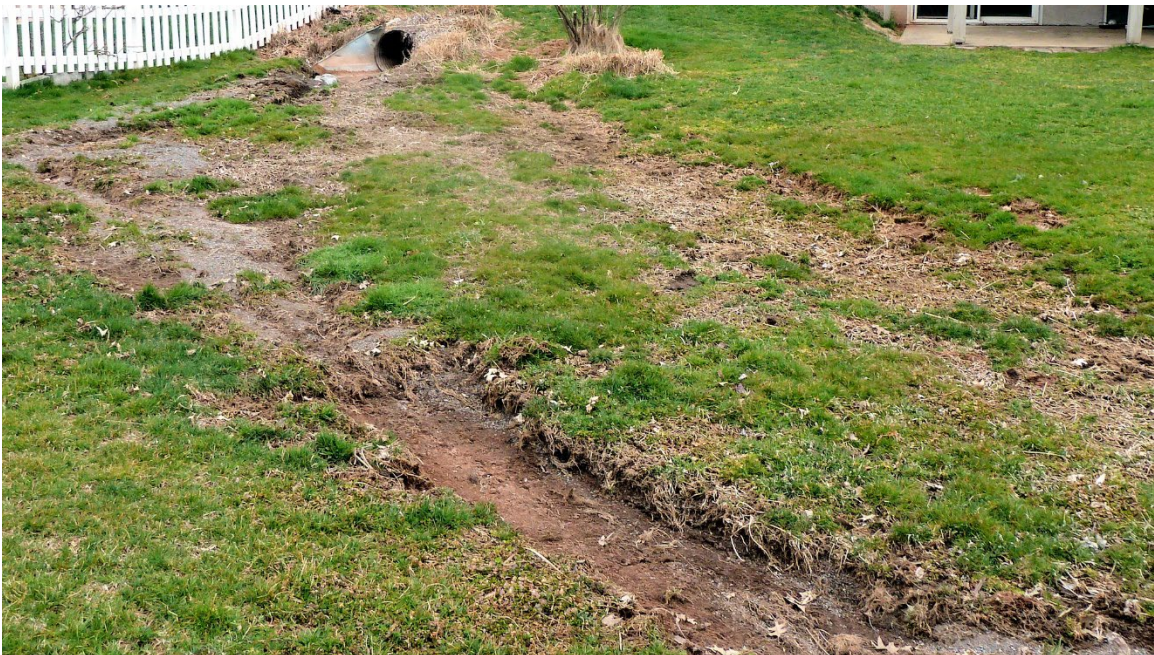
Erosion caused by flow from an inlet into a basin. In this case, the flow rate was too high for the lawn. To repair this so that the problem doesn't return will probably require the installation of protective matting prior to reseeding, or the addition of a rock apron energy dissipator.

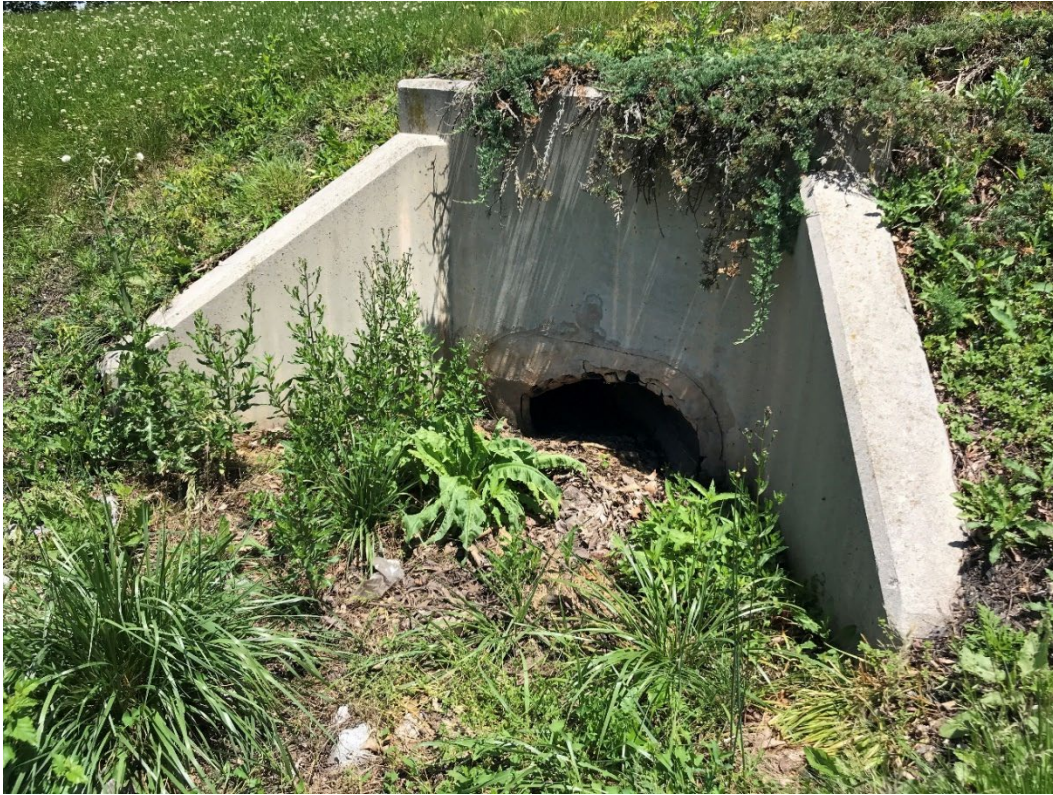
This inlet/endwall carries flow into a basin. It has not been well maintained, and has become partly blocked with sediment, which has started to support vegetation, further interfering with the flow. There is a rock apron under the sediment that must be cleaned out, or the rip-rap replaced.

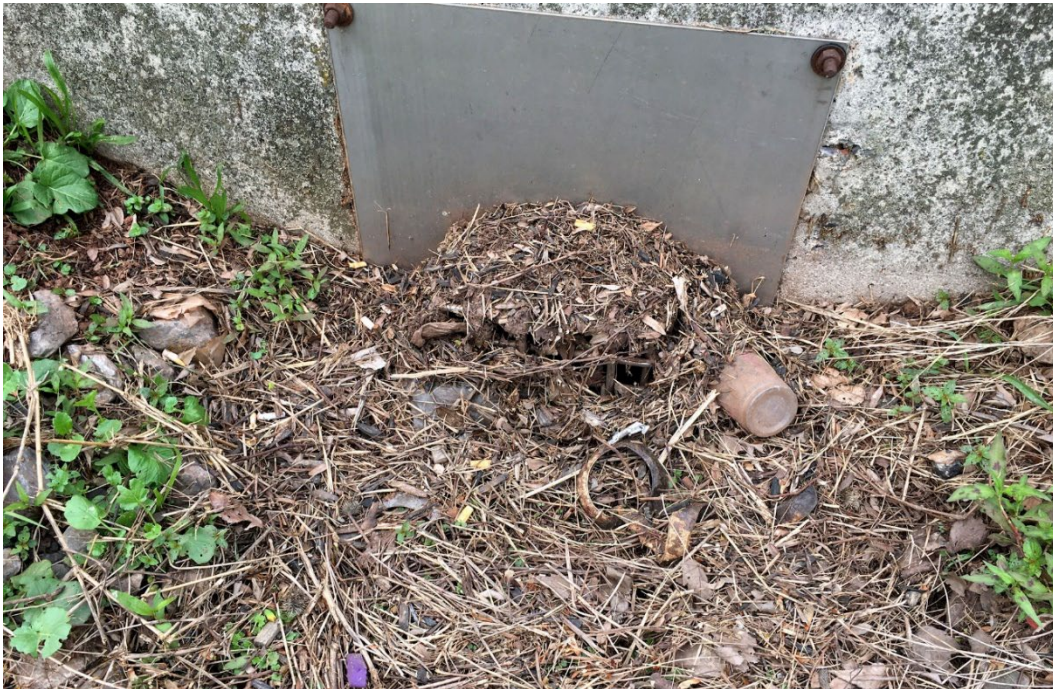
This outlet structure has a trash rack which has not been kept clean. This can lead to the basin not draining quickly enough, potentially damaging or killing the vegetation in the basin, requiring replacement of the plants.

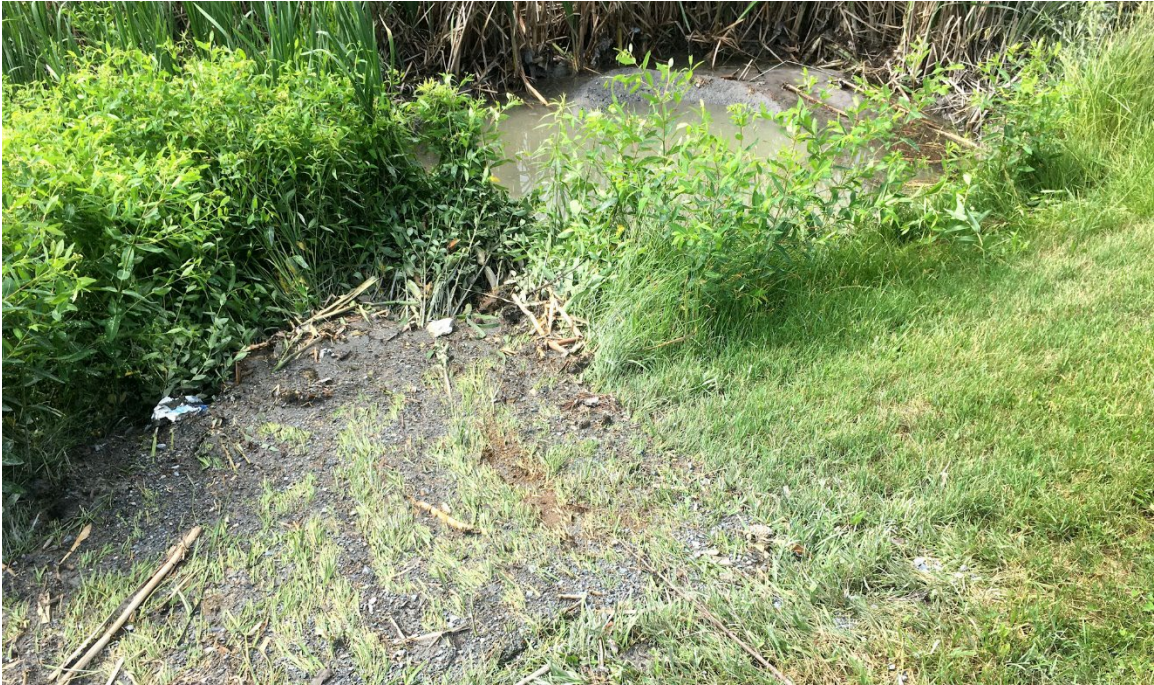
Sediment accumulation can occur in a basin if the water entering the basin is contaminated. If the sediment reduces the volume of water the basin is able to store, it must be removed and the basin restored to its original condition.

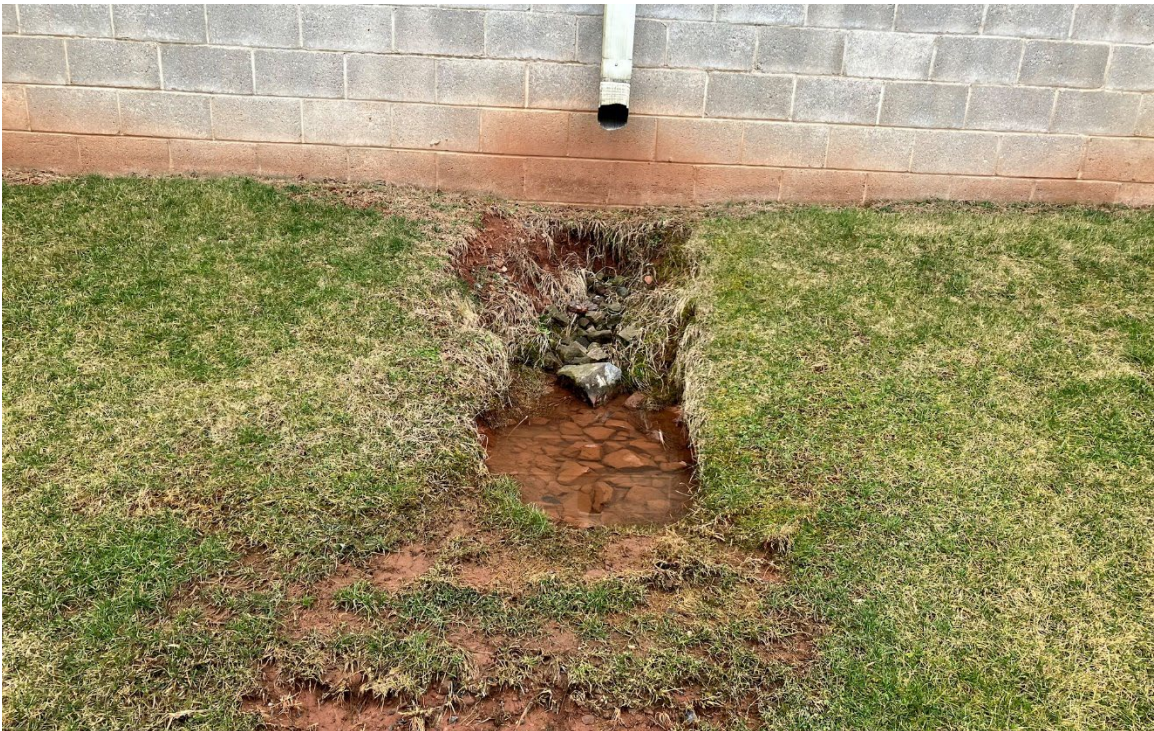
Downspouts often need erosion protection. This one drains directly into a basin. The eroded area needs to be repaired and reseeded, and protection, either rip-rap or a splash block.

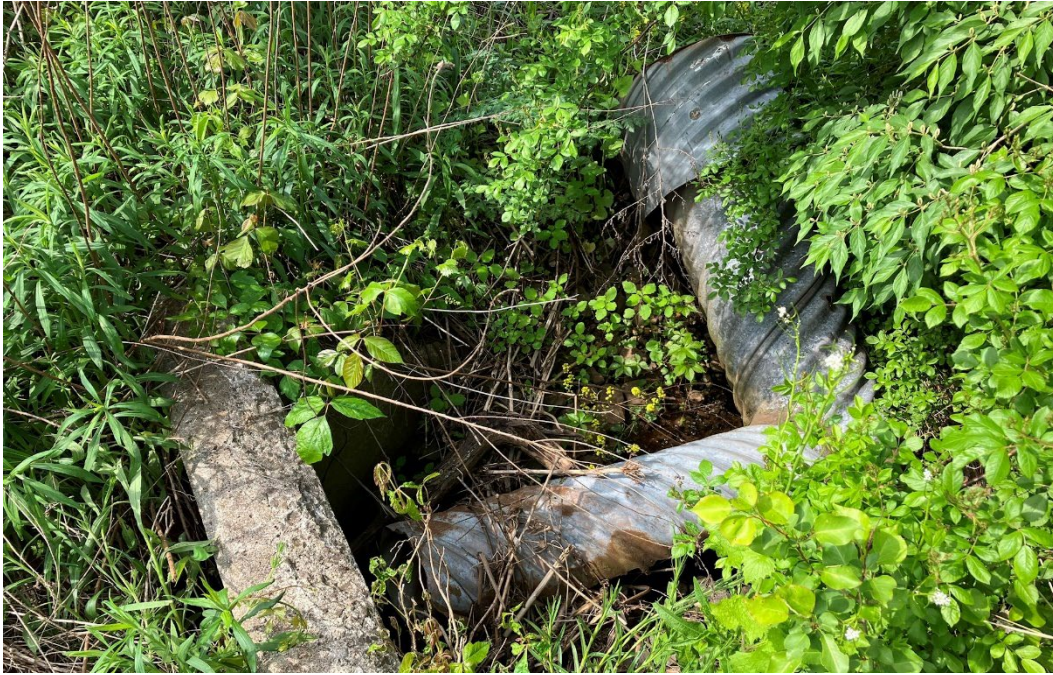
During construction basins are configured to catch the sediment running off the bare earth where lawn will eventually be planted. Once the lawns are established and no bare earth remains, the basin will be reconfigured to act as a detention basin, its final form. In the basin above, the subdivision's developer never changed the configuration from the sediment control basin. The corrugated metal riser pipe has since rusted off, leaving the basin not working for either configuration.

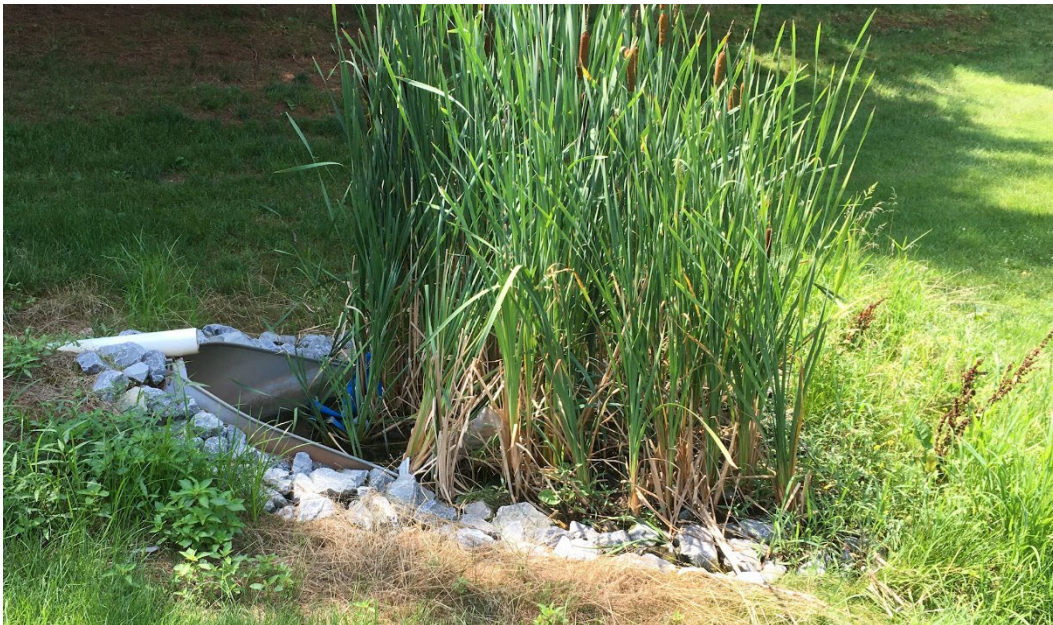
Rock apron at a basin inlet partly blocked with a dense growth of cattails (*Typha latifolia*). If the flow rate of water entering the basin is significantly slowed by the plants, they should be removed, and the rock apron restored to the original condition to prevent water from backing up upstream causing local flooding. If the flow rate is fairly low, the cattails may do a better job of filtering and slowing the flow than the rock apron alone.

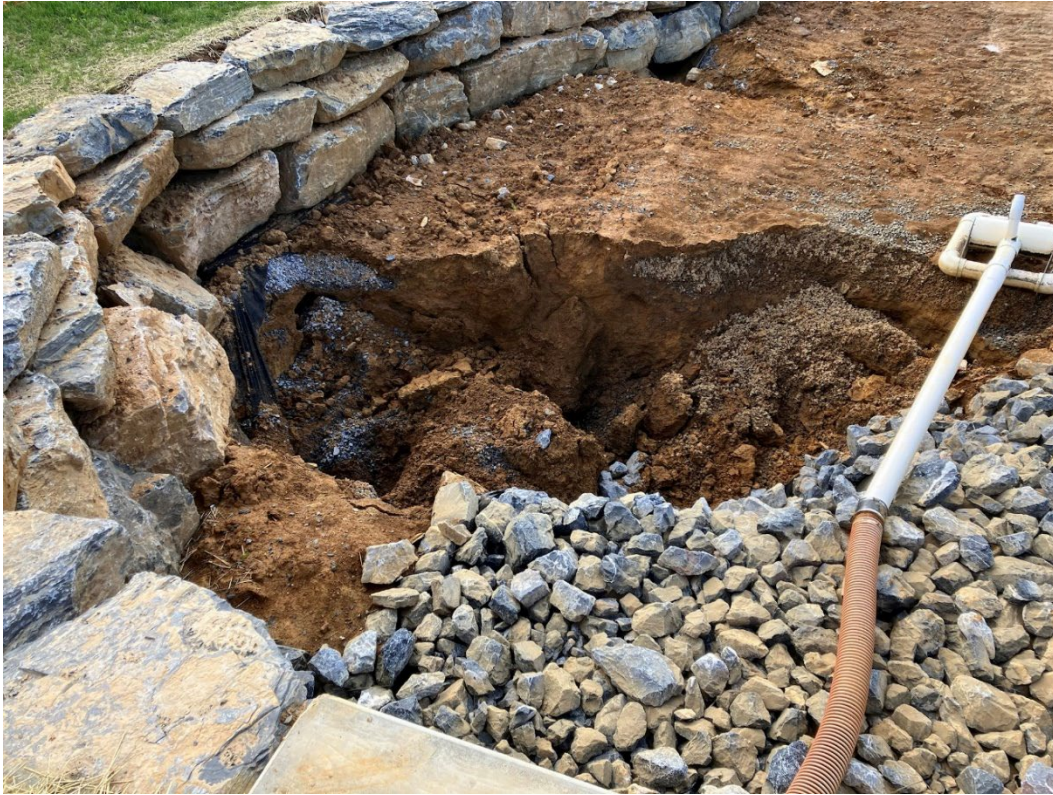
In areas where the bedrock is limestone (karst topography) erosion can lead to sinkholes. This one opened up in a stormwater basin. The sinkhole is substantially larger underground. This problem usually requires an engineered solution to prevent them from returning.

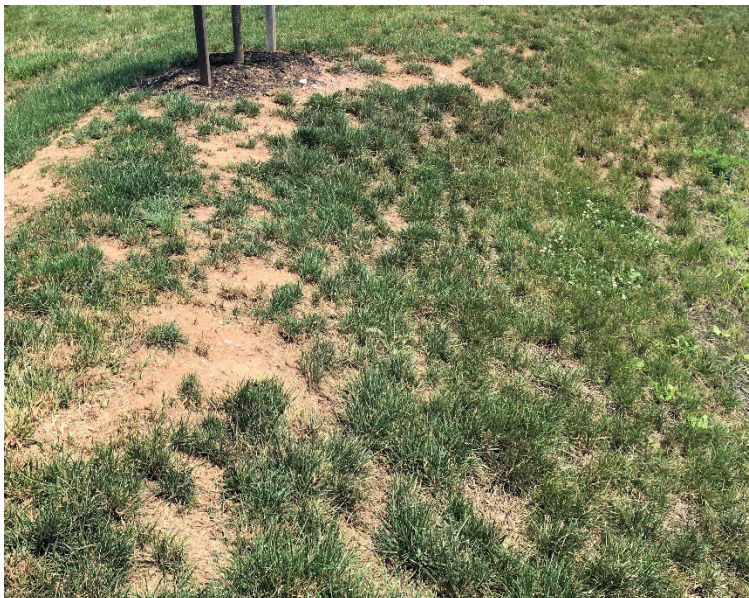
Bare Spots

If there are bare spots where the vegetation is not growing well, they should be reseeded. If the bare spots are being caused by problems, such as ponding of water, or erosion, the cause of the bare spots may need to be corrected in order to get the vegetation established. Bare spots will lead to erosion, sediment pollution into waterways, and potentially damage to the structure of the basin.

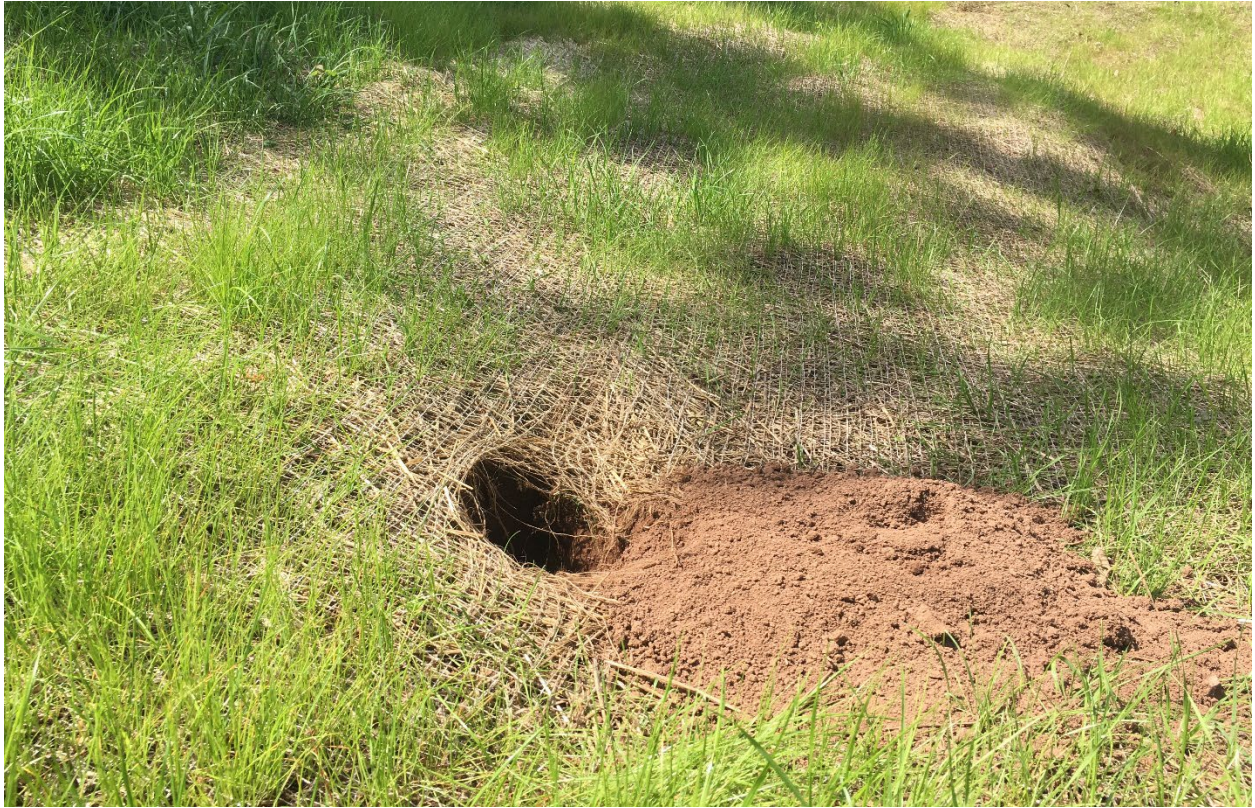
Animal burrows, such as from a ground hog, can damage the structure of a basin. If the burrow goes through the berm, it will lead to erosion and potential failure of the berm, necessitating very costly repairs.
